## I211 Start-up Failure

MPN: **WGI211ATSLJXZ**

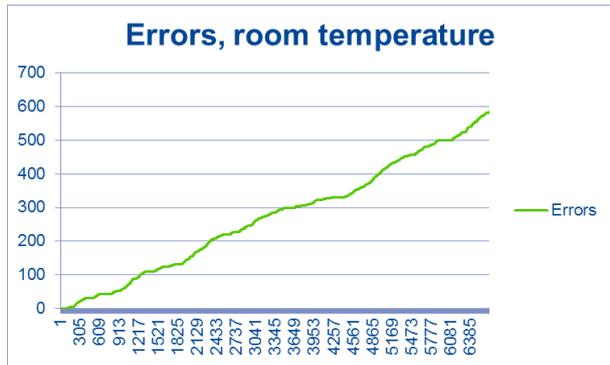
PCI Boot test data for S/N ...2180074 in room temperature. The failure rate was 8.8%. The line is fairly linear, so the failure rate seems "constant".

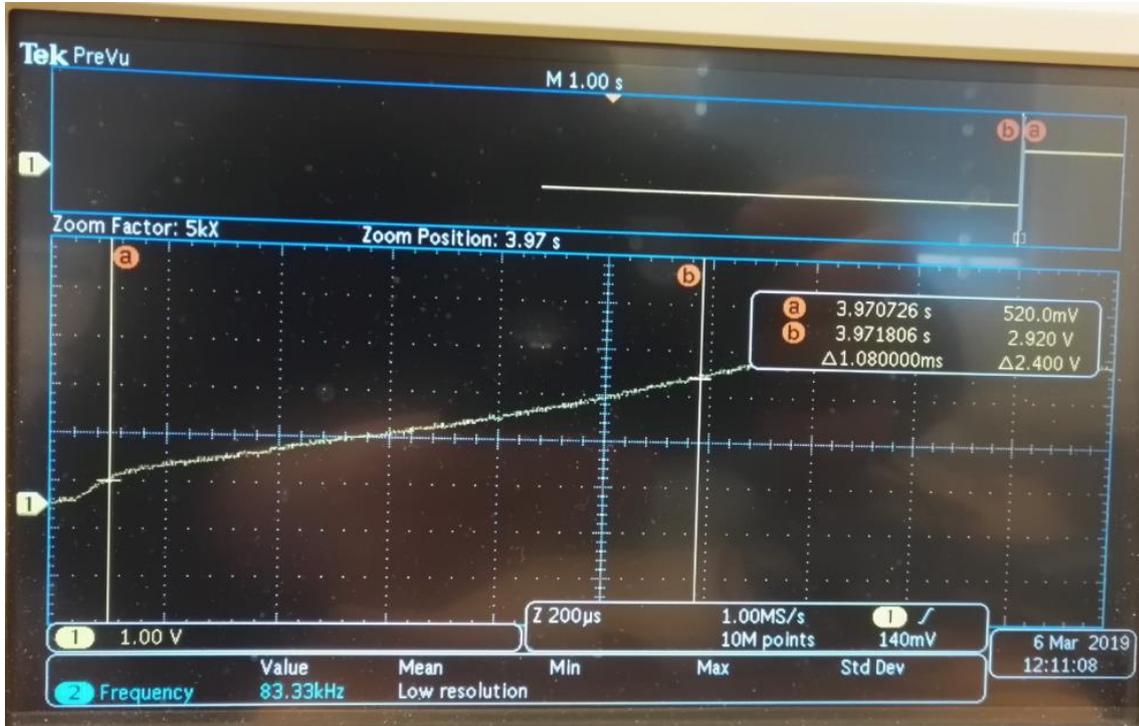
3V3 (C180)

Looks OK

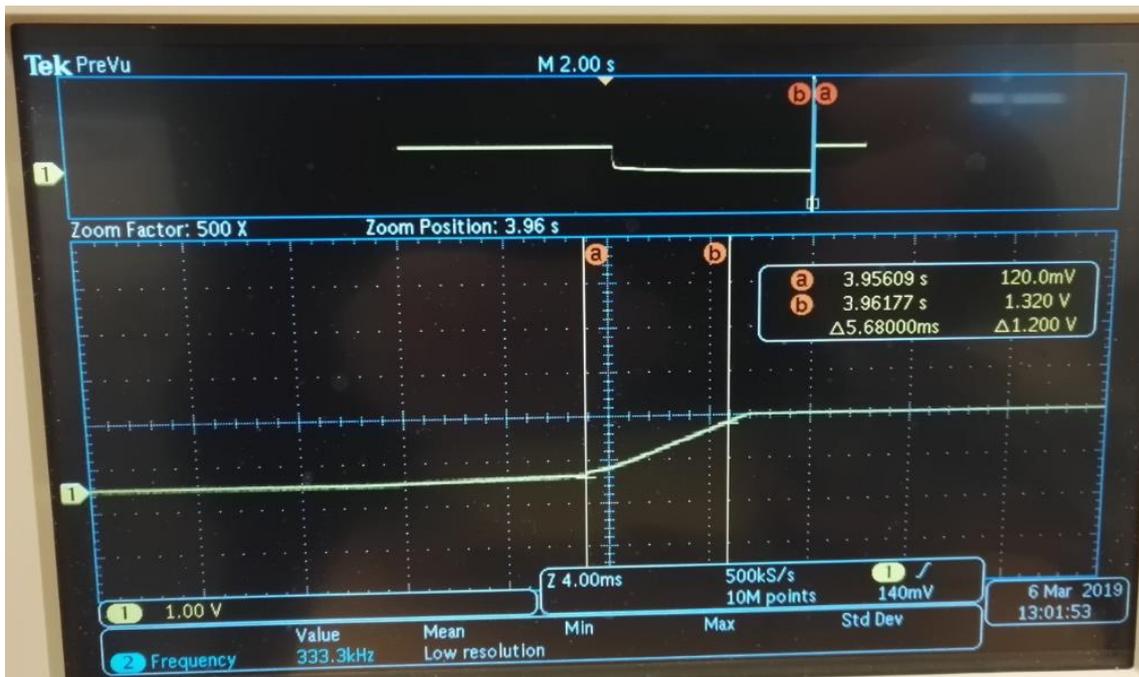
1V5 (C181)

Looks OK

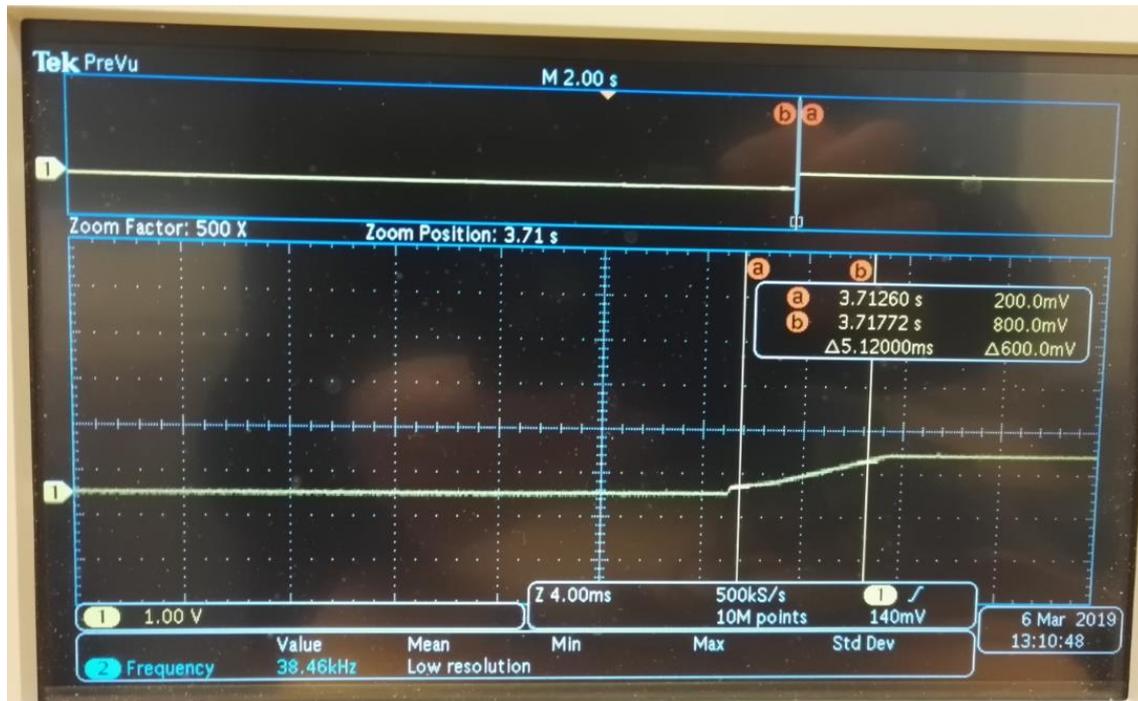
0V9 (C182)

Looks OK

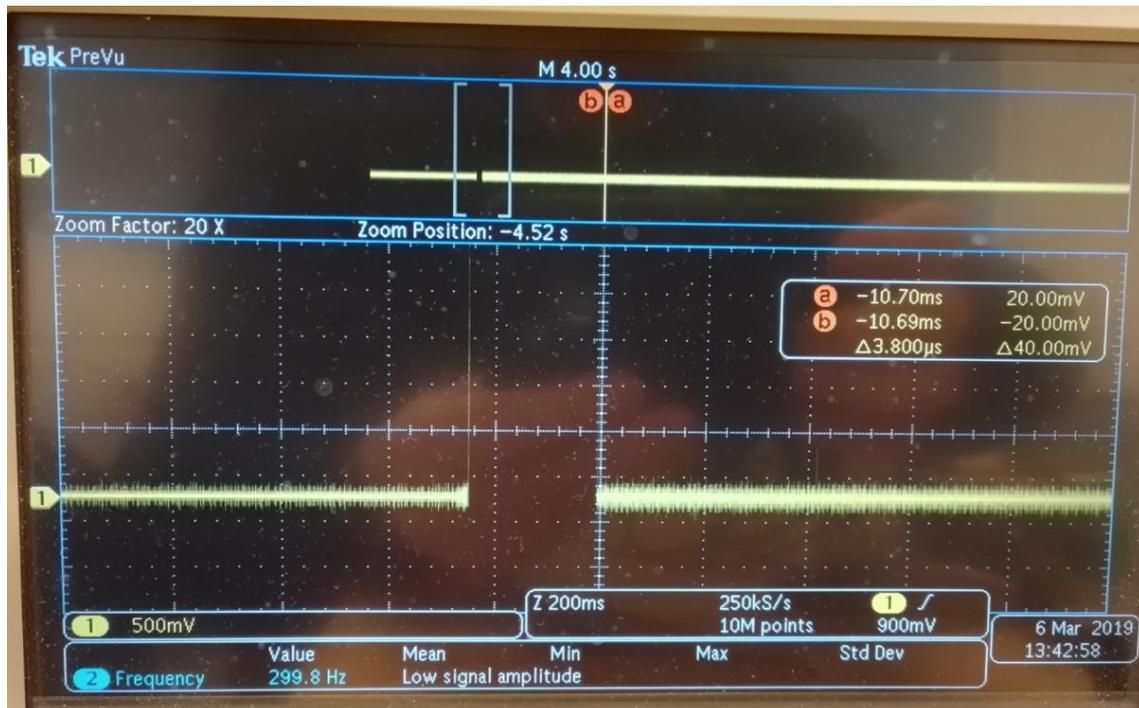
DEV\_OFF\_N (R109)

Is turned high for ~220ms during power-up and then dragged down

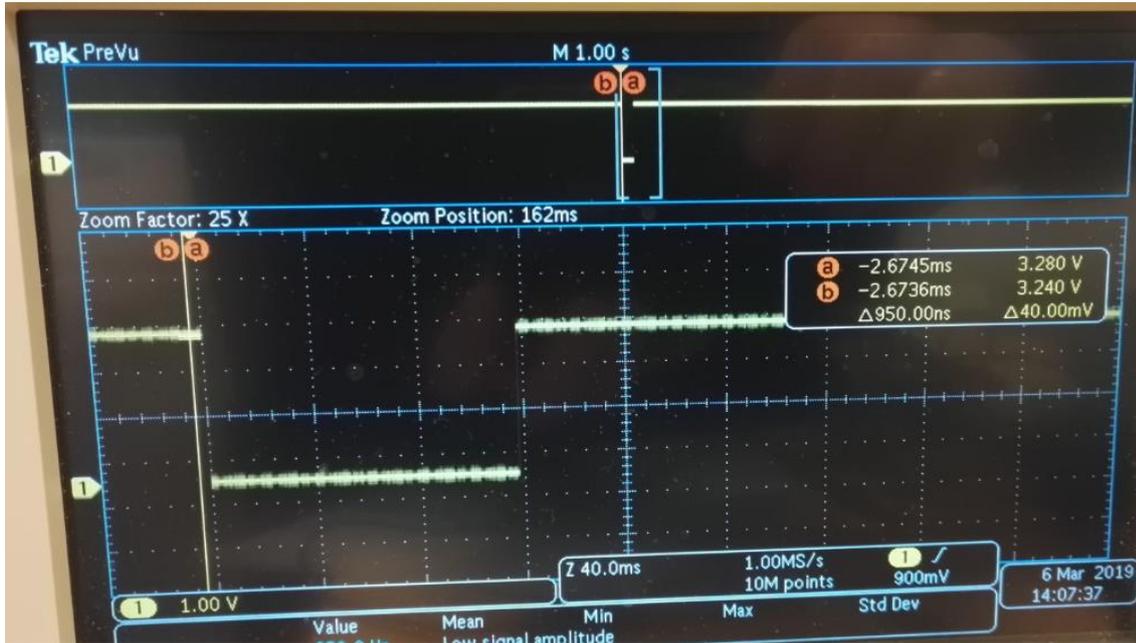
**PE\_RST\_N (R223)**

Is high for quite a long while, until drivers touch it during Linux boot, then driven low for ~120ms and back

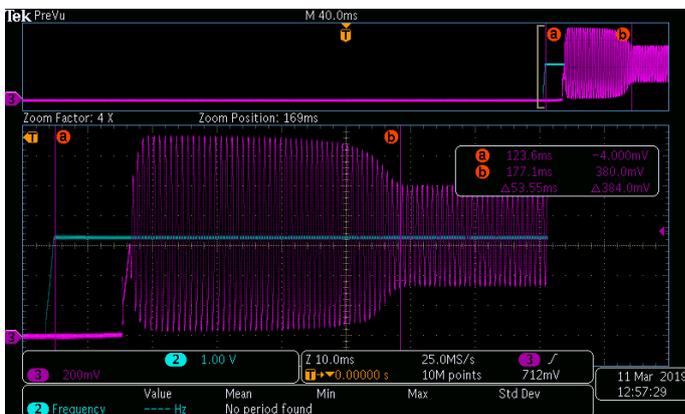
**Crystal X4 (C105)**

0-10 ms

10ms – 50ms

50 ms -

0V

25 MHz 10 mV - 1.3V

25 MHz 350 mV - 0.9V
