Failure Analysis Report (Reporte de Análisis de Falla)

Responsable:	Marco Jimenez	TOP Assy Name:	CIE-170-5171-405	FAR # (DDMMAACC):	31/10/2024
Nombre del componente:	CIE-060-0887-001	Proyecto:	CIENA RSP	Fecha de hallazgo (DDMMYY):	25/10/2024
Descripción del componente:	IC, PROC, XEON D-1713NTE, 4 CORE, 45W, 3.30 GHZ, 2227-FCBGA, ESD CDM 150V, NON-COMPLIANT TO CPS REQ	Serial	B35FD403	Fecha de cierre (DDMMYY):	31/10/2024
Estatus:	Replace components	Estación de falla:	ICT	Yield Caído (%):

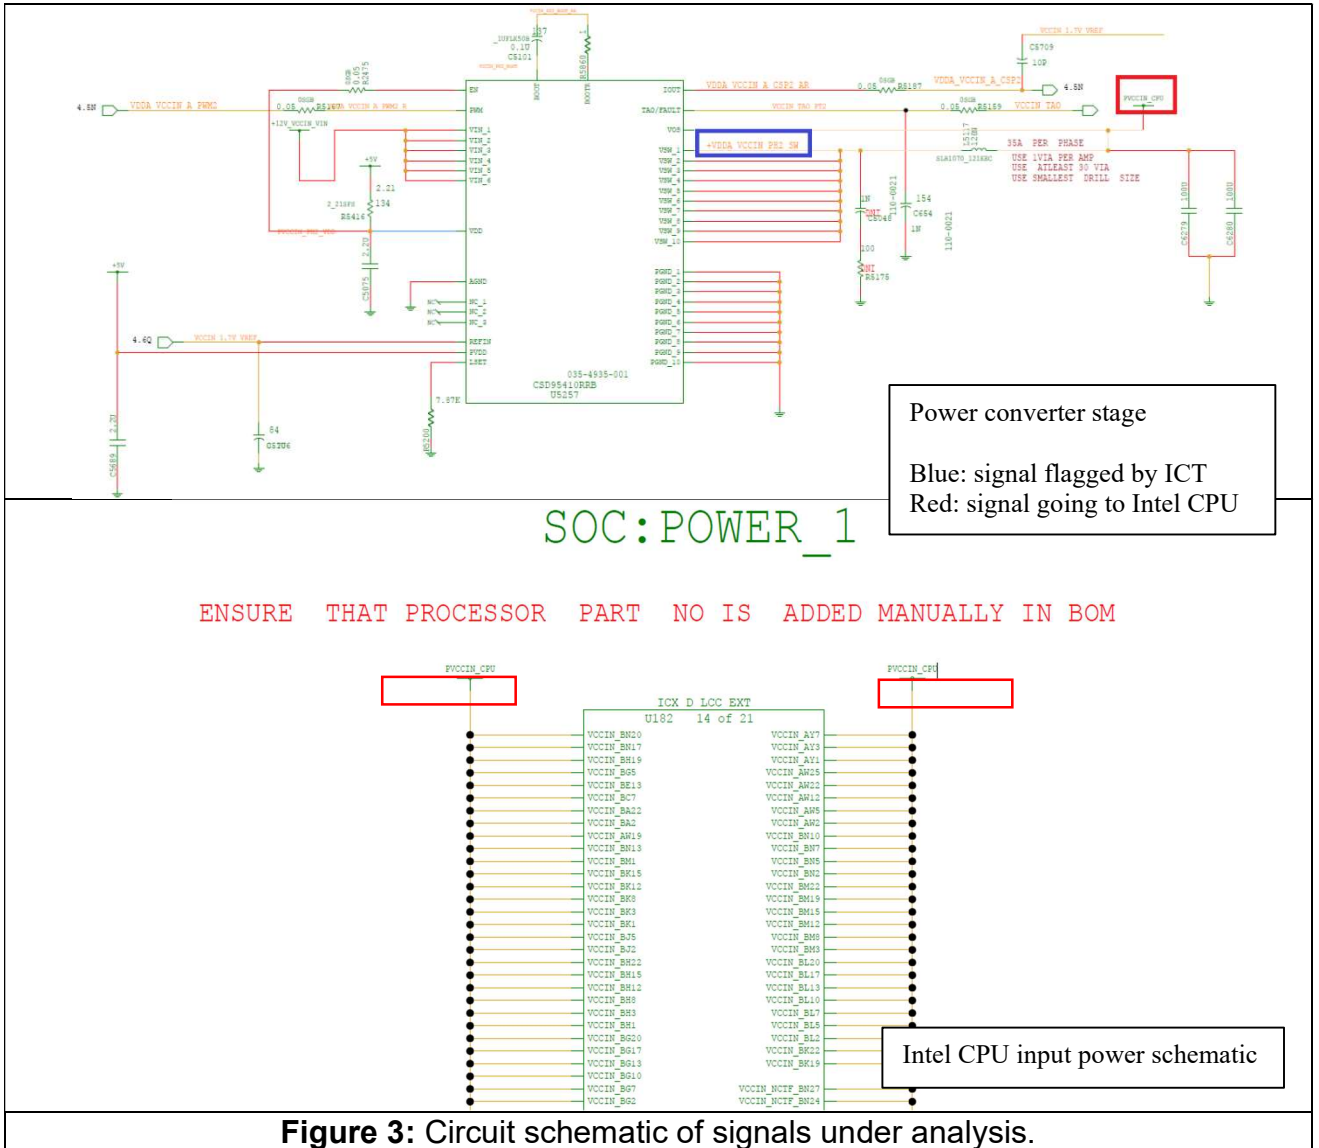
Figure 3: Circuit schematic of signals under analysis.

In Figure 3, the circuit of the affected signal is shown, the affected signal is highlighted in a red rectangle, the signal flagged by ICT is highlighted with the blue rectangle. In the next schematic snippet, the input stage of the PVCCIN_CPU to the U182 BGA is shown.

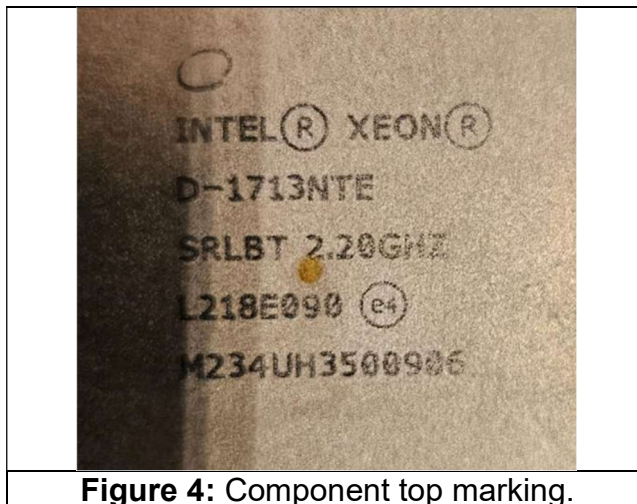
Figure 4: Component top marking.

1. We performed double validation with visual inspection, discarding the possibility of an inverted component or incorrect top marking, no visible defects were found confirming the results from AOI, as shown in Figure 4.
2. We performed double validation with manual XRAY, discarding solder shorts confirming the results from AXI, as shown in Figure 5
3. In order to isolate the short between power supply and load, the inductor L5117 was removed from the PCBA.
4. After removing L5117, the impedance of the +VDDA_VCCIN_PH2_SW (blue rectangle) signal was restored, effectively isolating the issue at U182.
5. Board was sent to remove U182.
6. After U182 removal, the PVCCIN_CPU (red rectangle) node was measured in the bare pads of the PCBA, and the impedance was restored, further confirming that the low impedance was located at the IC at U182.

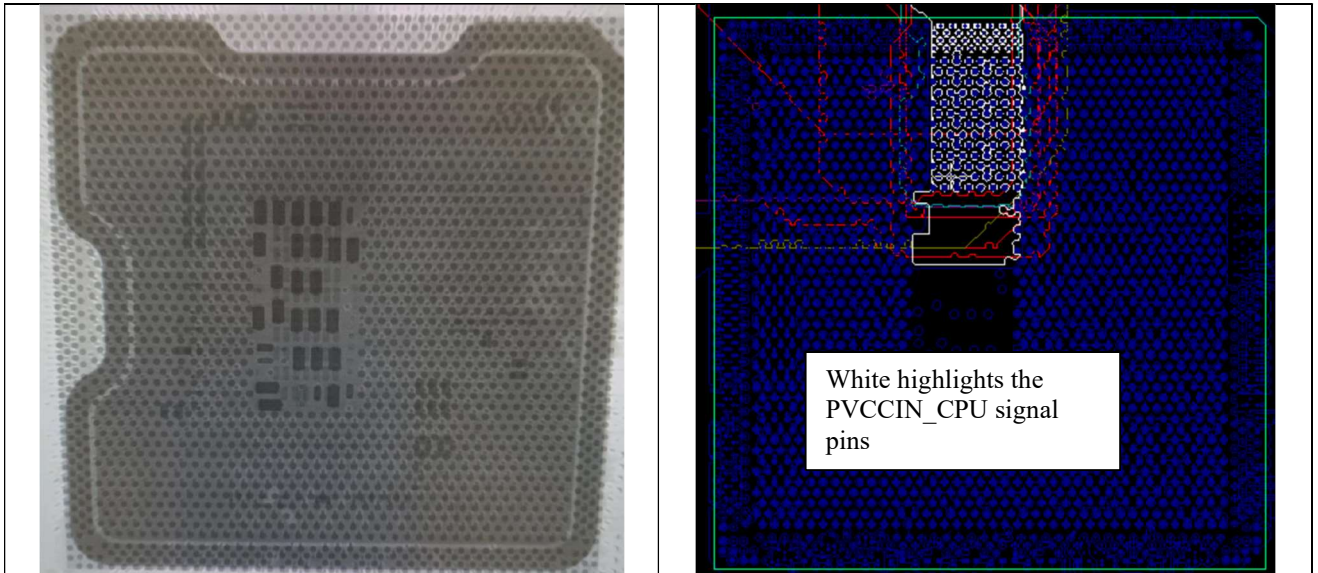
Figure 5: XRAY image of the component under analysis installed in the PCBA, no solder shorts are in present— side to side comparison with Gerber file where pins under analysis are highlighted.

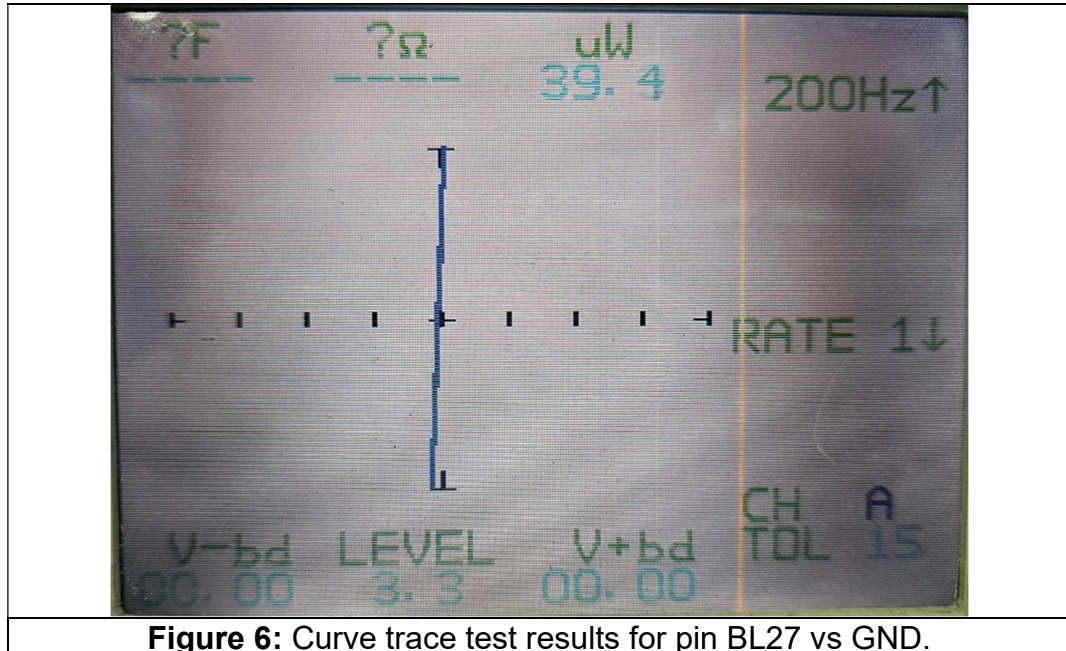
Figure 6: Curve trace test results for pin BL27 vs GND.

In order to verify if the component was internally damaged, curve tracer test was performed in the component, specifically in pin BL27 vs GND. The result is in Figure 6.

It is evident that the Intel BGA (U182) has an internal short to GND in pin the pins corresponding to PVCCIN_CPU signal.

- No noticeable manufacturing defects could be found in the board.
- The defect is located at the ASIC, curve tracer test confirmed the short.
- To determine the exact nature of the defect, further component analysis of this IC is required.
