Intel® Core™2 Extreme Processor QX9000^Δ Series and Intel® Core™2 Quad Processor Q9000^Δ, Q9000S^Δ, Q8000^Δ and Q8000S^Δ Series

Specification Update

— on 45 nm Process in the 775-land LGA Package

August 2009

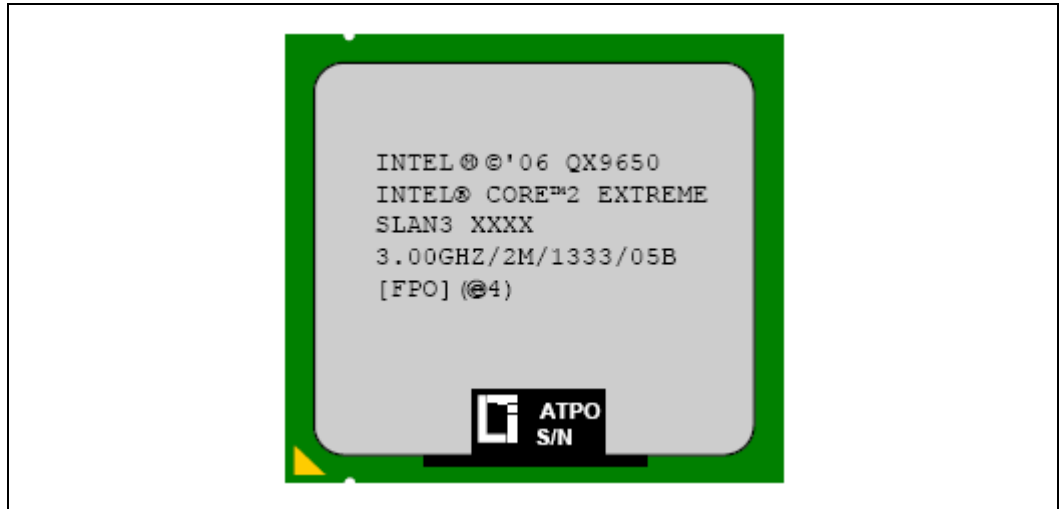
Figure 1. Processor Top-Side Markings Example (Intel® Core™2 Extreme Processor QX9650)

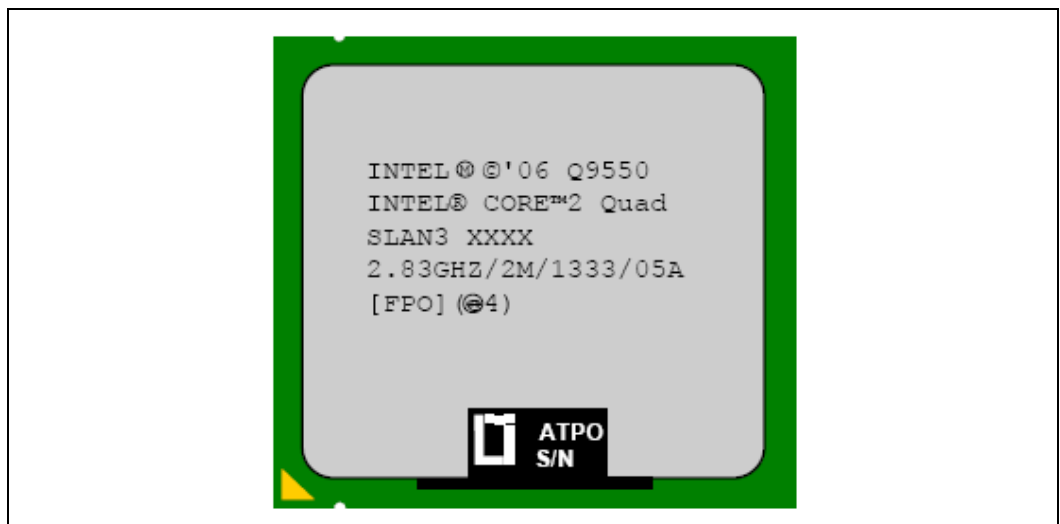
Figure 2. Processor Top-Side Markings Example (Intel® Core™2 Quad Processor Q9000 Series)
